2019 Fall Field Rep. Conference

Tim Anderson
Dairy Services Section Chief
Division of Food and Recreational Safety

Reminder about Milking Equipment Requirements

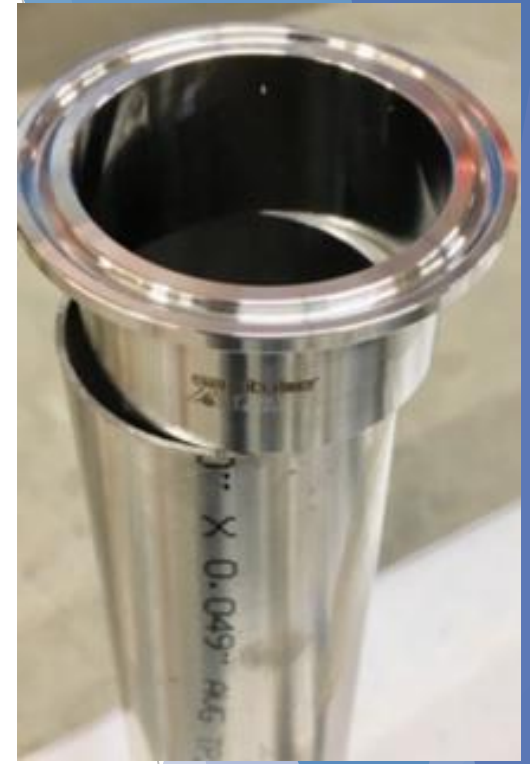
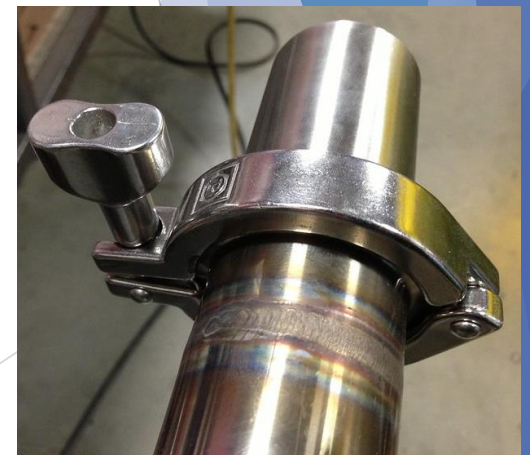
All stainless steel pipeline fittings must be continuously welded in accordance with 3-A Sanitary Standard 63-03 for Sanitary Fittings. A properly installed stainless steel butt-welded fitting is the only current sanitary method for milk pipeline construction. The photos to the right show an example of a butt weld fitting properly installed on sanitary piping.

On January 1, 2001, ~~recessless~~ or rolled-on ferrules were no longer accepted for milking pipeline installations.

State law [Wis. Admin. Code § ATCP 65.14(1)] requires that milking and a milk handling system shall comply with 3-A Accepted Practices for the Design, Fabrication and Installation of Milking and Milk Handling Equipment, No. 606-05 (www.3-a.org). This practice states that all product and solution contact surfaces shall be free of imperfections such as pits, folds, and crevices. ~~Recessless~~ or rolled-on fittings are **only** acceptable for temporarily modifying or repairing existing onsite farm milk handling systems with fittings installed with no cracks or crevices. The temporary modifications or repairs must be replaced with a proper sanitary fitting as soon as practical.

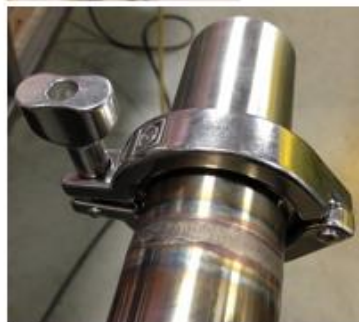
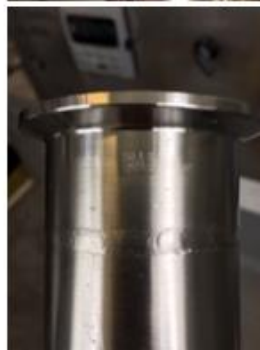
Examples of a butt weld fitting properly installed on sanitary piping:

The practice of face welding a rolled on ferrule or the use of a quick weld ferrule (socket ferrules) are not acceptable alternatives and are not considered to be of sanitary design.
